**PEDESTRIAN SAFETY
IMPACTS OF CURB
EXTENSIONS:
A CASE STUDY**

Final Report

SPR 304-321

July 2005

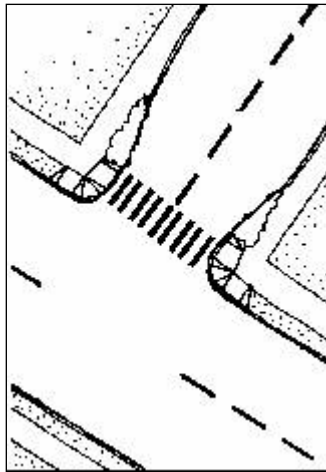
Figure 1.0: Curb extension diagram

When the intended purpose of curb extensions is for traffic calming, they typically extend into the travel lane to reduce speeds by narrowing the lanes. A series of curb extensions at intersection or mid-block locations is typically used to reduce speeds along a corridor. Bulbouts at intersections can reduce the speeds of turning vehicles and still maintain an adequate turning radius.

It is important to note that the curb extensions in Albany were for improved pedestrian safety and not intended as traffic calming features. The design of the curb extensions terminated the edge of the bulbout two feet from the travel lanes and did not narrow the lanes or increase congestion. The benefits for pedestrians were increased visibility and shorter crossing distance.

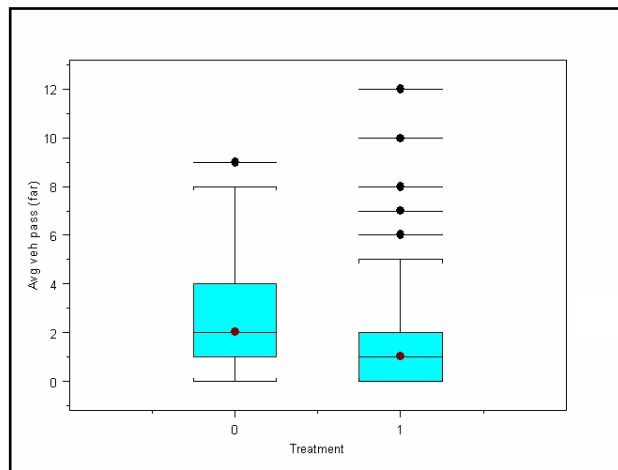
Figures 3.0 and 3.1 show the spread of the number of vehicles that passed before a crossing in the near and far lanes respectively. In both lanes the treatment (curb extension) side had a lower mean, but they also had the overall highest number of vehicles that passed before a pedestrian cross. These high values seem to be a random event, because the observations showed that the pedestrian was in plain view and there were no other factors that were different from other crossings.

The analysis of the *average number of vehicles that pass before a pedestrian-cross* showed fewer passing for crossings from the side with the curb extension compared to crossings from the unimproved side. This reduction for the curb extension side occurred in both the near and far lanes with a statistically significant difference in means. (Table 3.0). The mean number of vehicles that passed before the pedestrian could cross from the side with no curb extension was 2.58 for the near and 2.36 for the far lane.

For pedestrians crossing from the curb extension side, the mean number of vehicles that passed was reduced to 1.81 for the near lane and 1.76 for the far, resulting in a reduction of 42.7% and 33.9% respectively. Acceptable p-values of less than 0.05 from the t-test analysis validate the statistical difference in the means. The analysis included n = 219 pedestrian crossings for the near lane and n = 214 for the far lane. There was a difference in samples sizes because the case where a pedestrian crossed and one lane was clear of traffic only counted as an observation for the lane where vehicles were present.
